APOLLO 13 MISSION REPORT

SEPTEMBER 1970

MSC-02680

Mission Evaluation Team

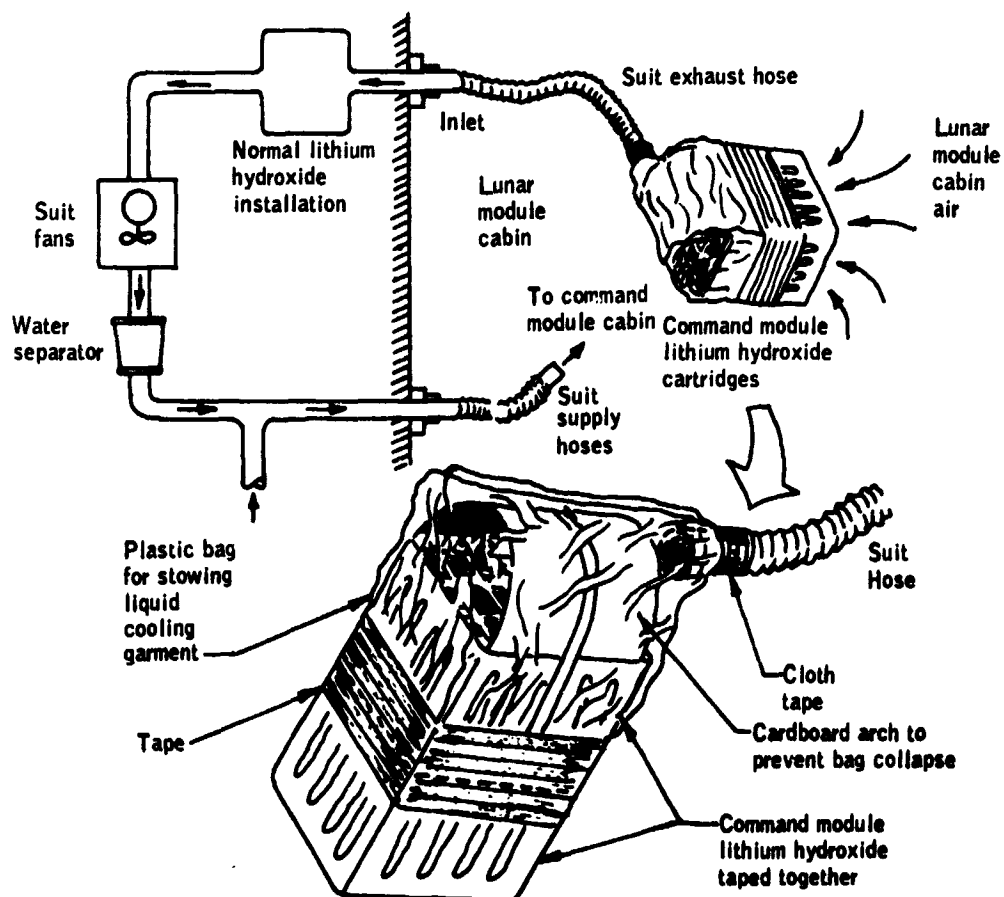
Figure 6.7-1.- Supplemental carbon dioxide removal system.

It became apparent that there were insufficient lithium hydroxide cartridges in the lunar module to support the abort mission, even with allowable carbon dioxide levels extended to a partial pressure of 15 mm Hg. With ground instructions, a system was constructed which attached a command module lithium hydroxide cartridge to each of two lunar module suit hoses. The Commander's remaining hose was placed in the tunnel area to provide fresh oxygen to the command module, while the Lunar Module Pilot's remaining hose was positioned in the lunar module environmental control area. At a later time, a second cartridge was added in series to the cartridges initially installed, as shown in figure 6.7-1. In each case, the drop in carbon dioxide levels reported by the ground showed satisfactory operation of this improvised carbon dioxide removal system.

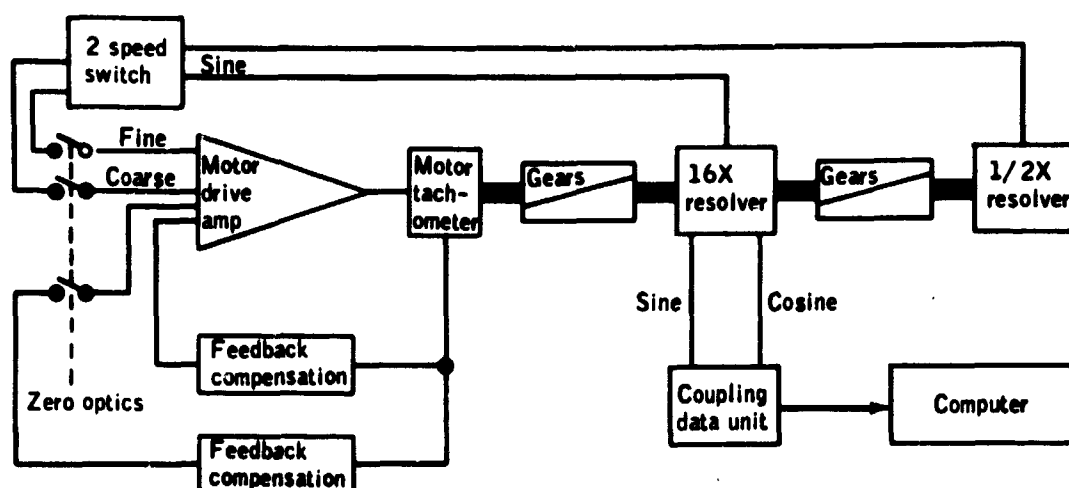
Figure 14-2.- Zero optics mode circuitry.

A simplified schematic of the optics shaft servo loop mechanization is shown in figure 14-2. In the zero optics mode, the sine outputs of

the half-speed and 16-speed resolvers are routed through a coarse/fine switching network to the motor drive amplifier and are used to null the system. Rate feedback from the motor tachometer is routed to the drive amplifier through a compensation network which removes any bias in the signal. When the zero optics mode is selected, the coupling-data-unit counter and the computer register which contains the shaft angle are zeroed for 15 seconds and then released to follow the 16-speed resolver. The half-speed resolver, the fine/coarse switching network, and the tachometer feedback compensation are used only in the zero optics mode.

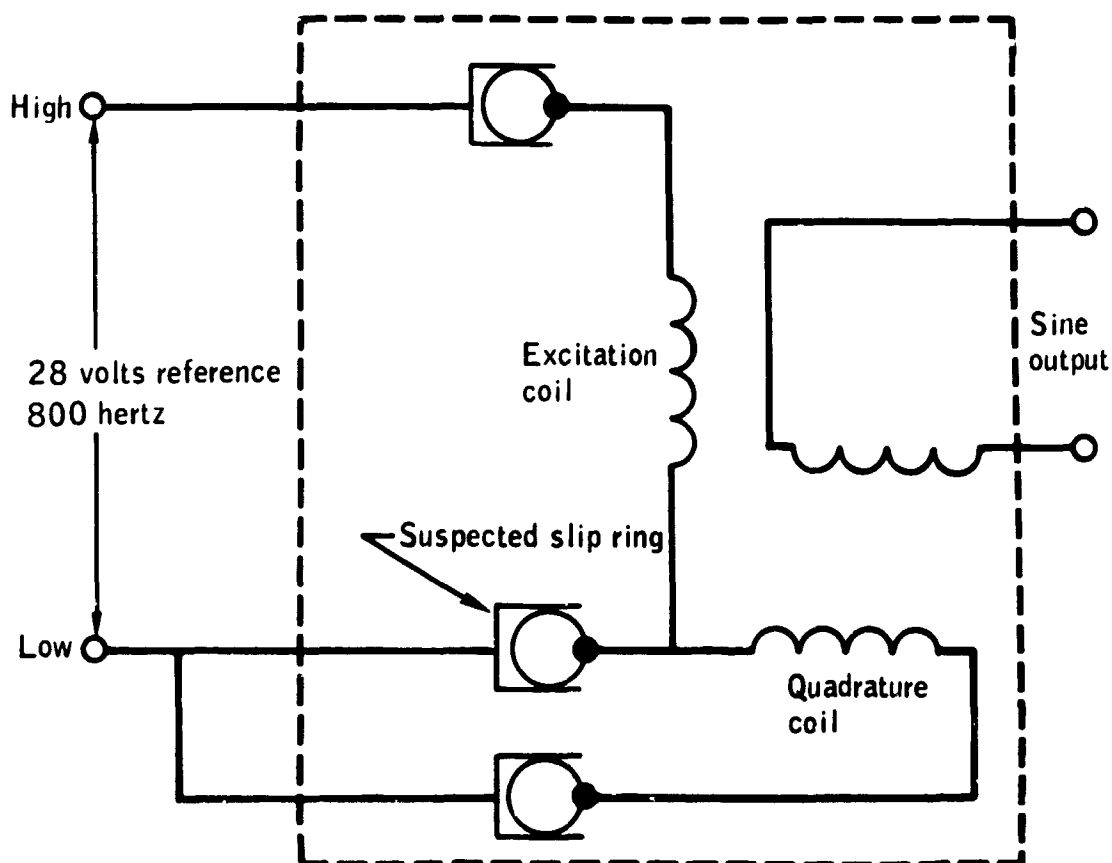
Figure 14-4.- One-half speed resolver.

The most likely candidate is the half-speed resolver, which is used only for the shaft axis and only to provide an unambiguous zero reference. The reference voltage is applied to the rotor through slip rings (fig. 14-3), connected as shown in figure 14-4. If any resistance is present in the common ground path through the slip ring, a portion of the reference voltage will appear across the quadrature winding and induce a finite output (different than zero). Zero output is equivalent to zero degrees in shaft rotation.

Simulated changes in slip ring impedance were made on the half-speed resolver in the shaft loop (fig. 14-4). An impedance of 50 ohms produced an offset of approximately plus 0.5 degree in sextant shaft angle. The trunnion loop does not use this type of resolver or connection.

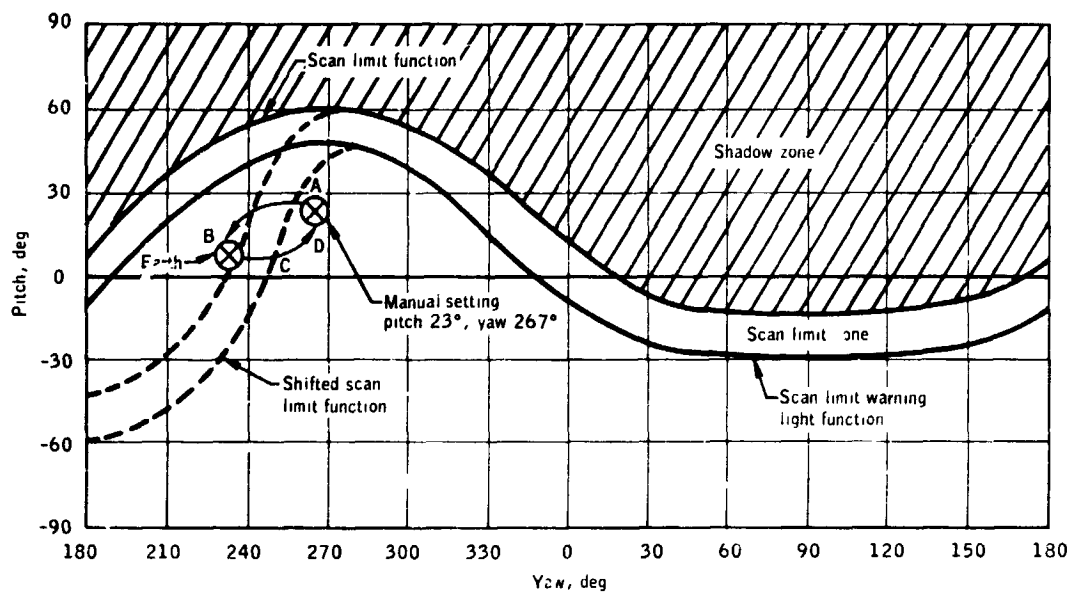
Figure 14-5.- Shift in scan-limit, scan-limit-warning illustrated.

Starting at 55:00:10 and continuing to 55:00:40, deep repetitive transients approximately every 5 seconds were noted on the phase modulated downlink carrier (fig. 14-5). This type of signature can be caused by a malfunction which would shift the scan-limit and scan-limit-warning function lines, as illustrated in figure 14-5. These function lines would have to shift such that they are both positioned between the antenna manual settings and the true line of sight to earth. Also, the antenna would have to be operating in the auto-reacquisition mode to provide these signatures. The antenna functions which caused the cyclic inflight RF signatures resulting from a shift in the function lines can be explained with the aid of figures 14-5 and 14-6, with the letters A, B, C, and D corresponding to events during the cycle. Starting at approximately 55:00:10, the antenna was switched from manual to auto reacquisition with the beamwidth switch in the medium-beam position. From point A to the scan limit function line just prior to point B, the antenna acquired the earth in wide beam. When the antenna reached the scan limit function line, the antenna control logic would switch the system to the manual

mode and drive back toward the manual settings until the scan limit warning function line at point C was reached, thereby maintaining wide-beam operation. When the antenna reaches the scan limit warning function line, the system would automatically switch to the medium-beam mode and continue to drive in the manual mode until the manual setting error was nulled out at point A. The antenna would then switch to the auto-track mode and repeat the cycle. The most important feature of this cycle is that the antenna moves at the manual scan rate between points B and D, which is confirmed by the rapid changes in the downlink signal strength.

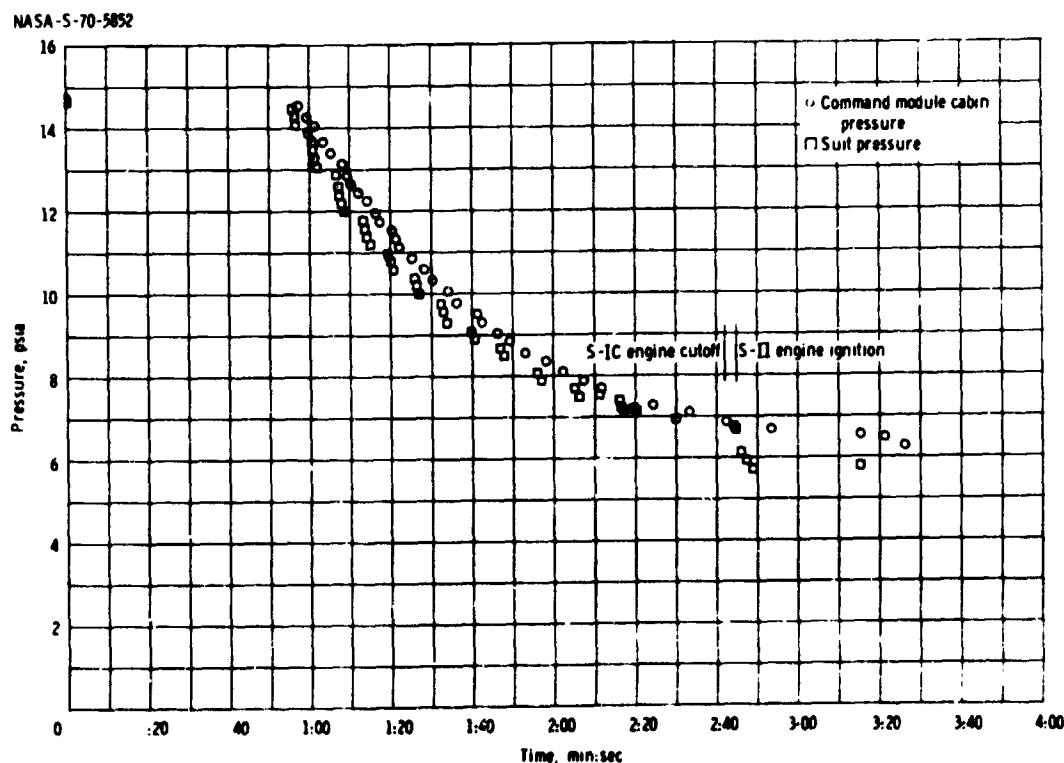
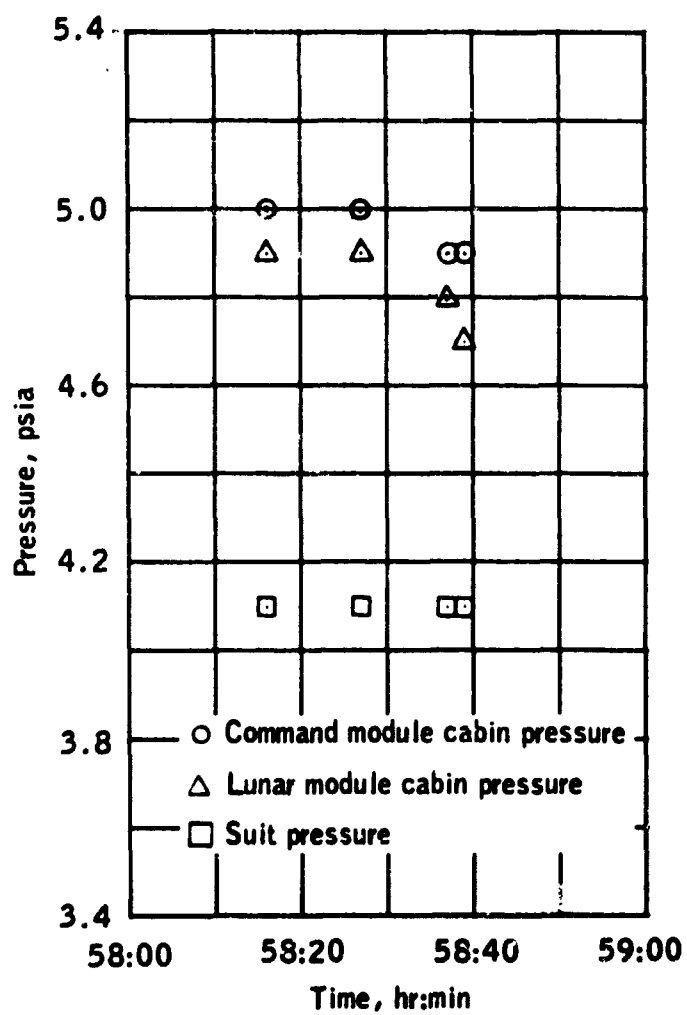
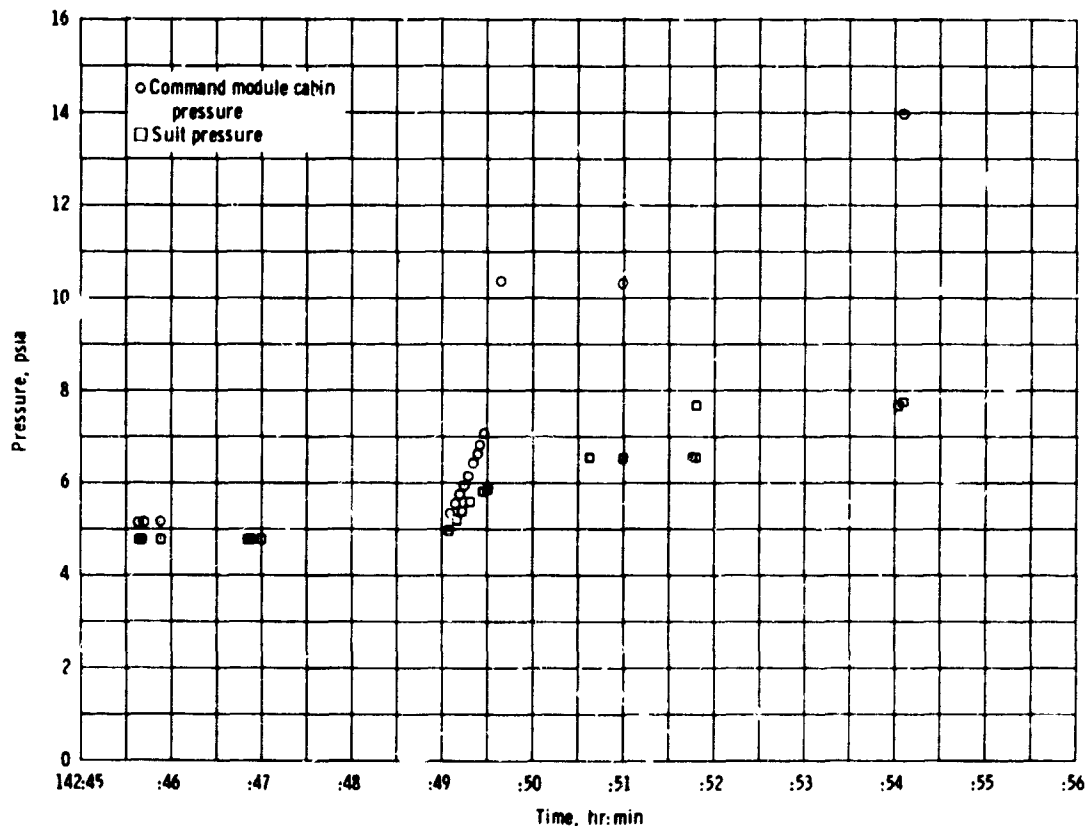
Figure 14-12.- Suit and cabin pressure.

During launch the suit pressure transducer reading remained consistent with cabin pressure until 00:02:45, then suddenly dropped from 6.7 to 5.7 psia coincidentally with S-II engine ignition (fig. 14-12). The difference between the two measurements decreased to only 0.2 by 1-1/2 hours, when the cabin reached its nominal regulated pressure of 5.0 psia. For this shirtsleeve mode, the suit and cabin pressure readings should be nearly equal. During normal variations in the command module cabin pressure, the suit pressure measurement responded sluggishly and indicated as much as 1 psi low. Subsequently, the measurement output decayed and remained in the 4.1 to 4.3 psia range for a cabin pressure of 5.0 psia until system deactivation at about 59 hours (fig. 14-12).

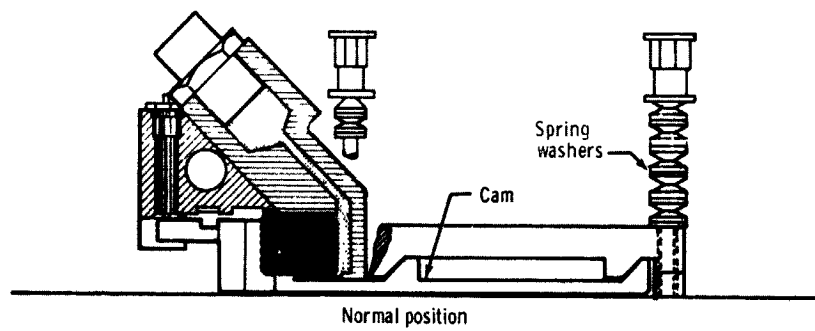
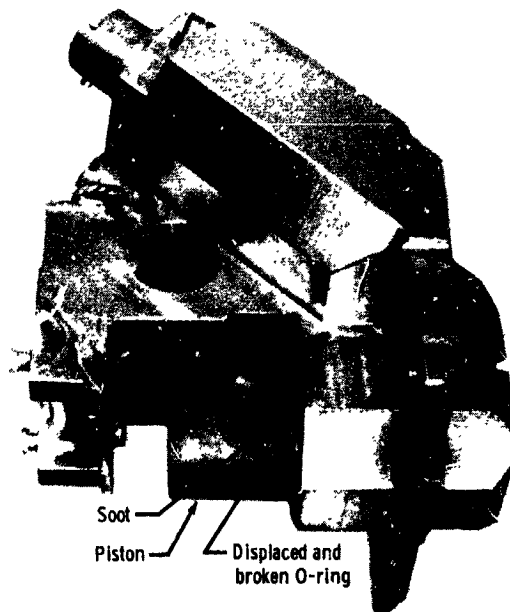
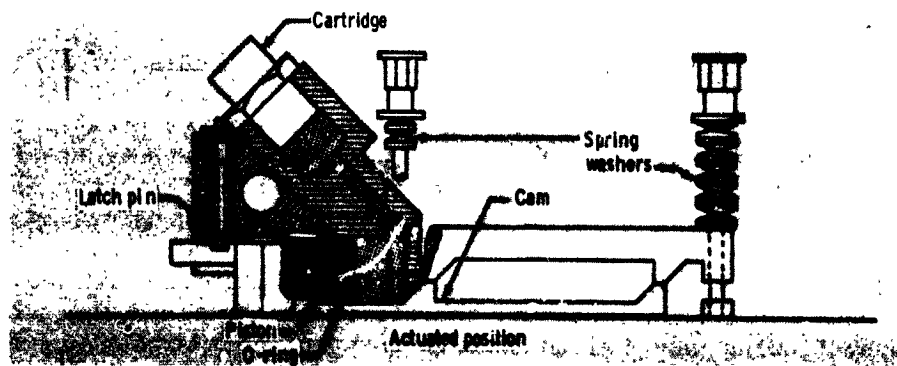
Figure 14-13.- Circuit interrupter.

During postflight inspection of the command module, propellant gas was noted to have escaped from the left-hand electrical circuit interrupter, mounted in the lower equipment bay, and deposited soot on adjacent equipment. The right-hand circuit interrupter showed no evidence of a gas leakage. The removed breech, showing the displaced O-ring and crushed attenuator block, is shown in figure 14-13.

The two interrupters open the electrical circuits about 30 milliseconds before the wires are severed by the command module/service module umbilical guillotine. As illustrated in the figure, a cam fork is moved by a piston, which is operated by propellant gas from redundant cartridges, to function a lift plate. Motion of this plate disconnects the male and female portions of electrical connectors located, respectively, in the lift plate and in the base plate of the interrupter. At the completion of the stroke, the fork is brought to rest by impacting and crushing an aluminum block mounted on the interrupter housing.

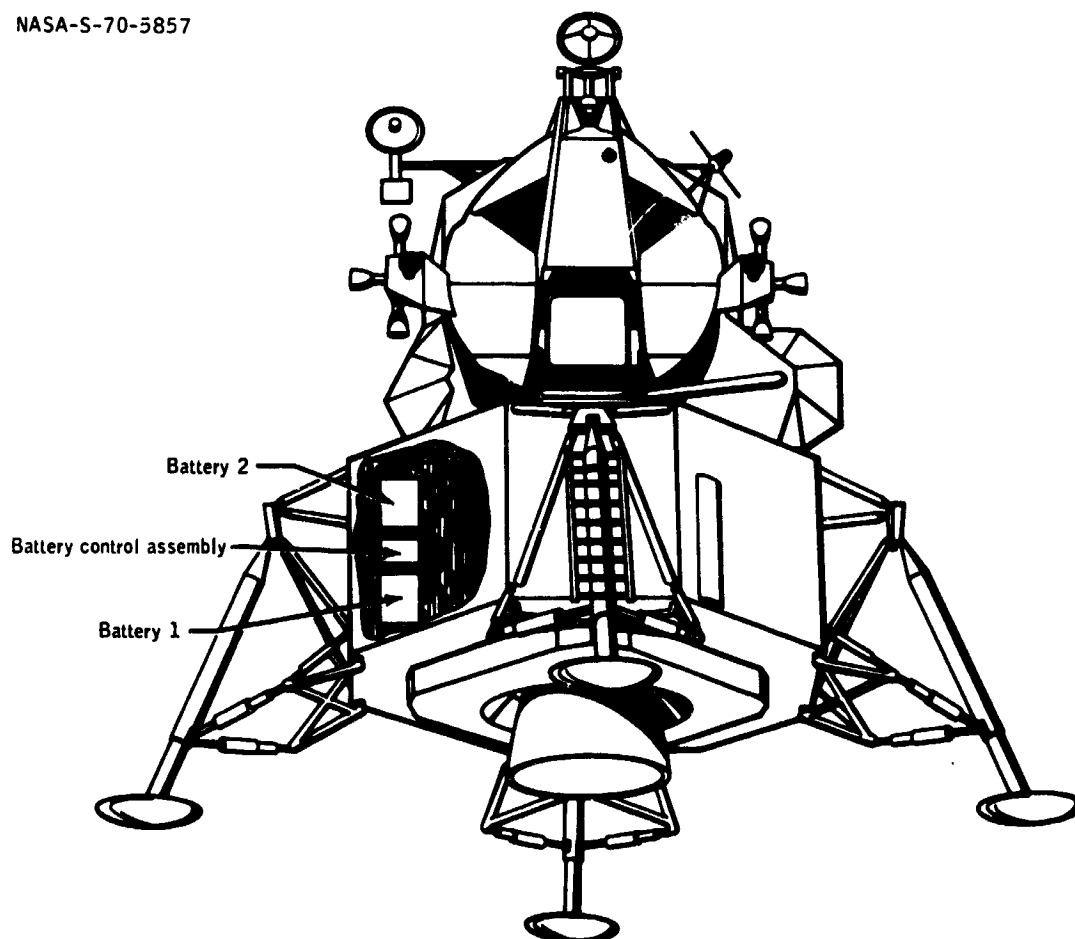
At 97 hours 14 minutes, the crew reported a thumping noise and snowflakes venting from quadrant 4 of the lunar module descent stage (fig. 14-15). All four descent batteries experienced current transients at 97:13:53 for about 2 seconds, with corresponding drops in dc bus voltage (fig. 14-16). Also, the water glycol pressure differential for the heat transport system decreased momentarily, indicating that the glycol pump momentarily slowed down.

Figure 14-15.- Descent stage battery location.

Evidence indicates that battery 2 may have experienced an electrical fault of some type. The most probable condition is electrolyte leaking from one or more cells and bridging the high-voltage or low-voltage terminal to the battery case (fig. 14-17). This bridging results in water electrolysis and subsequent ignition of the hydrogen and oxygen so generated. The accompanying "explosion" would then blow off or rupture the seal of the battery lid and cause both a thump and venting of the free liquids in the battery case, resulting in "snowflakes."

For Apollo 14 and subsequent missions, the descent batteries will be modified to minimize the hazards associated with electrolyte leakage.

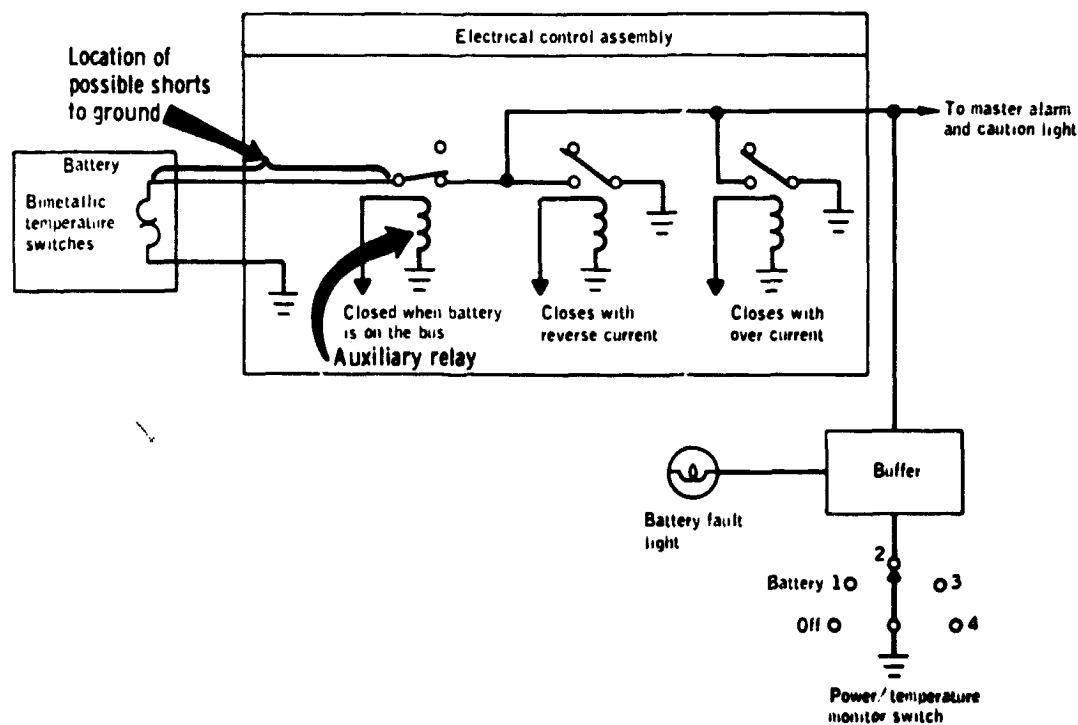
The battery malfunction light illuminated at about 100 hours with a corresponding master alarm. The malfunction, isolated to battery 2, could have been caused by an overcurrent, a reverse-current condition, an over-temperature condition, or possibly an erroneous indication. The logic for these malfunction conditions is shown in figure 14-18.

Figure 14-18.- Battery 2 malfunction circuit.

A battery overcurrent can be ruled out because automatic removal of the battery from the bus would have occurred.

A reverse-current condition can be ruled out because, if the battery is removed from and reapplied to the bus, the reverse-current circuit has a built-in delay of about 5 seconds before the reverse-current relay is again activated to illuminate the light. Battery power was removed from and replaced on the bus in flight, and the light immediately illuminated again when the battery was reconnected.

An over-temperature condition can be ruled out because, after the battery was replaced on the bus, the light remained illuminated for a brief period and then began flickering intermittently. A flickering light cannot be caused by the temperature sensing switch because of a temperature hysteresis of approximately 20° F in the switch. The water glycol loop temperature also indicated that the battery temperature was normal.

Either a short between the temperature switch wires to ground or a contamination in the auxiliary relay would actuate the light. The shorted condition could have resulted from electrolyte shorting within the battery case associated with the current surges discussed in the previous section. Contamination of the auxiliary relay has occurred in the past, and relays already packaged were not retrofitted since a false over-temperature indication can be identified as it was here.

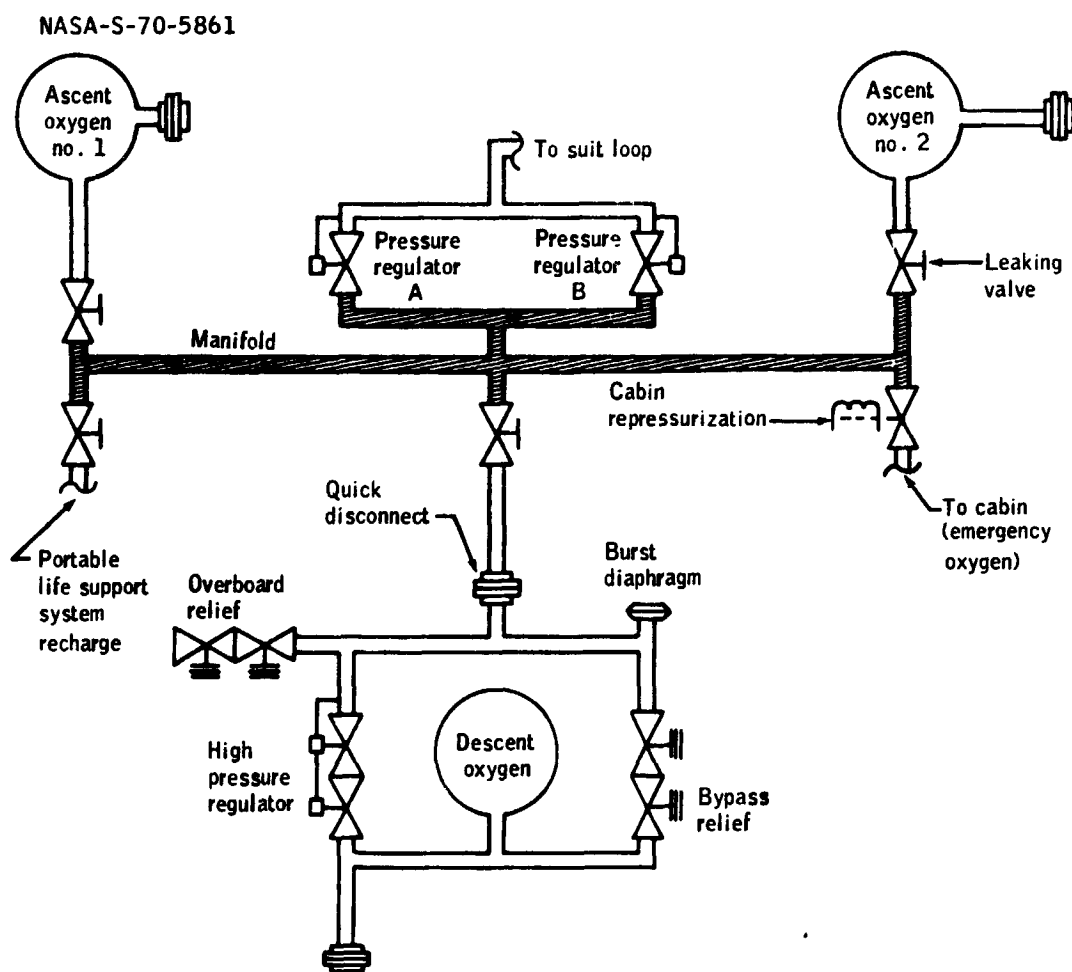
During the flight, the pressure in the ascent stage oxygen tank 2 increased, indicating a reverse leakage through the shutoff valve from the oxygen manifold (fig. 14-19) into the tank. The leak rate, with a maximum differential pressure of 193 psi, varied from about 0.22 lb/hr (70 000 scc/hr) to zero when the tank pressure reached manifold pressure. Allowable leakage for the valve in either direction is 360 scc/hr. Pre-flight test data indicate a reverse leakage of 360 scc/hr and no excessive leaking in the forward direction.

The internal portion of three valves of this type had been replaced previously on the spacecraft because of excessive leakage through the ascent oxygen tank 1 shutoff valve. In one valve, a rolled O-ring

Figure 14-19.- Oxygen-supply system.

(fig. 14-20) caused the leakage. When the valve is installed, the forward O-ring can be rolled and damaged when it passes the manifold port. In the other two valves, the cause was not identified and was assumed to be contamination.

Leak tests previously performed on the valve were inadequate, in that only reverse leakage at high pressure was determined. For future vehicles, forward and reverse leakage at both high and low pressures will be measured to detect any defective valves.
